# Case Study

**Bone line restoration with  
ReGum<sup>TM</sup> Vet**

**Dr. Jen Mathis, DVM**

**4 months follow up: 2.5Y old English Sheepdog/Poodle mix DVM  
Jennifer Mathis**

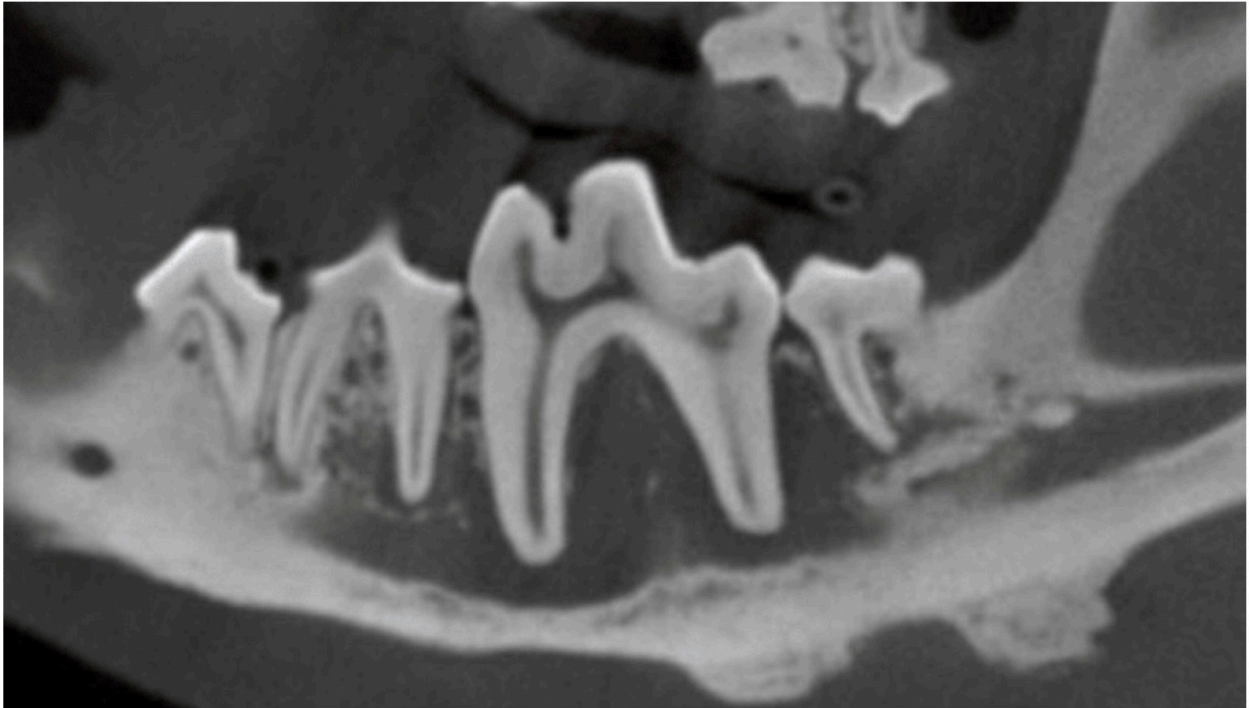
The internal structure of the affected tooth showed disease at the root tips, leading to infection. This infection had spread into the mandibular canal and affected nearby teeth. Although there was reactive bony proliferation on the ventral aspect, significant bone loss was also noted, which posed a risk for a pathological mandibular fracture.

Below: CT Cross Section of Disease

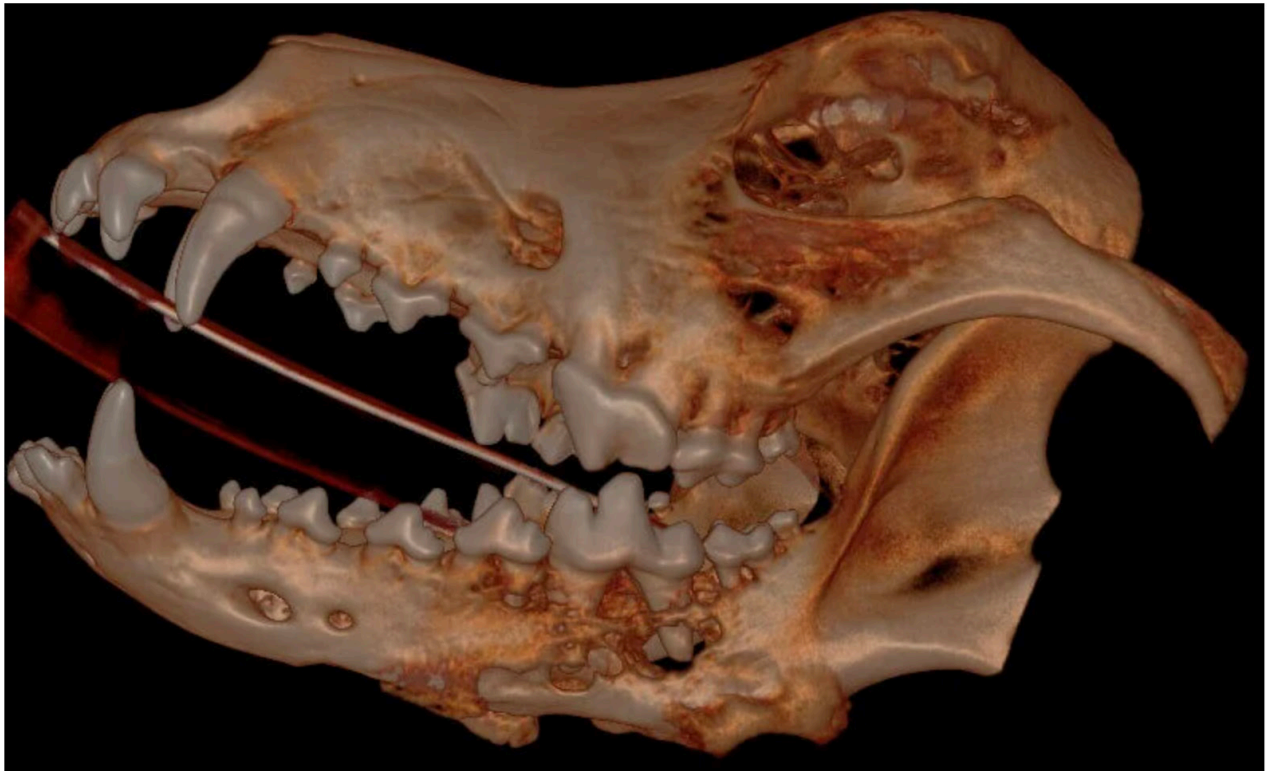
A firm swelling was detected on the left mandibular region. While the exact cause is unclear, it is suspected that trauma occurring between 10 and 24 months of age led to the death of the lower molar. Another possible cause is Mandibular Periostitis Ossificans (MPO), a developmental condition seen in large breed dogs. In MPO cases, the swelling typically resolves on its own. However, Daisy's condition, if MPO, would extend beyond the usual timeline, making trauma the more likely cause.

Below: 3D Hard Tissue Overview (left side)

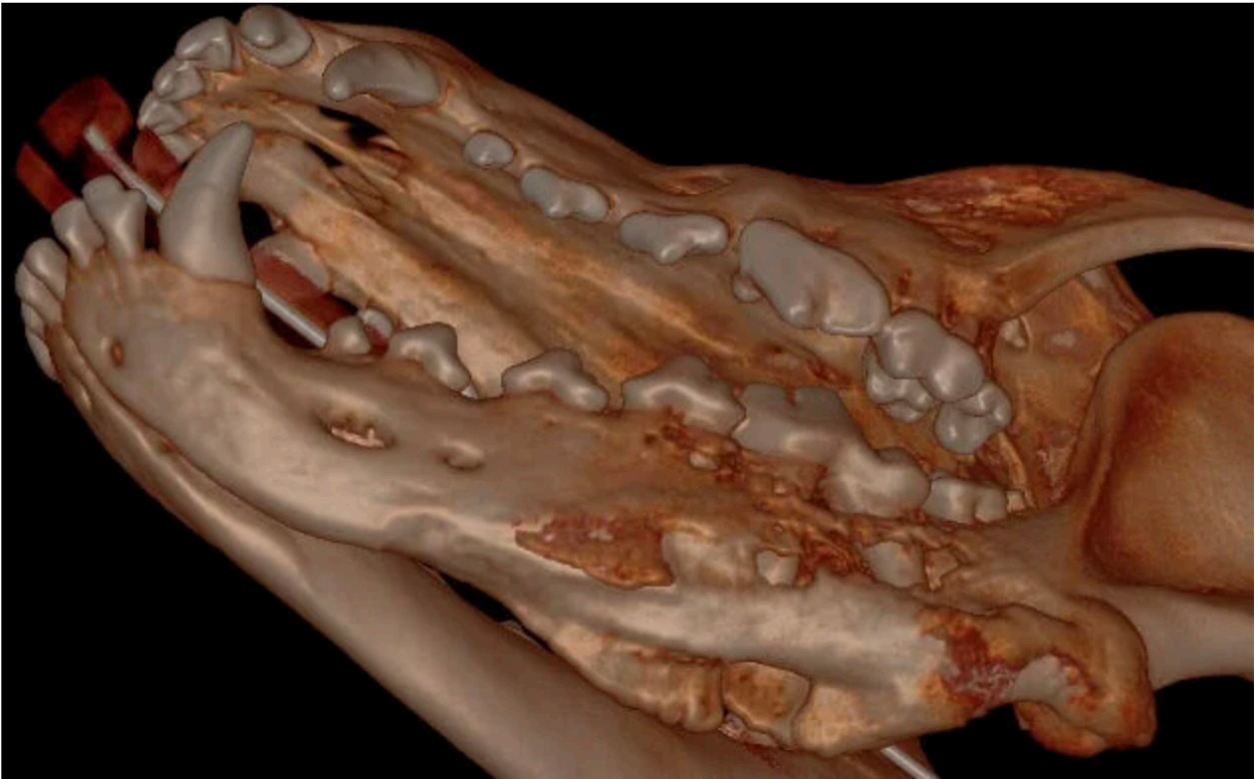
**Below: CT Cross Section of Disease**

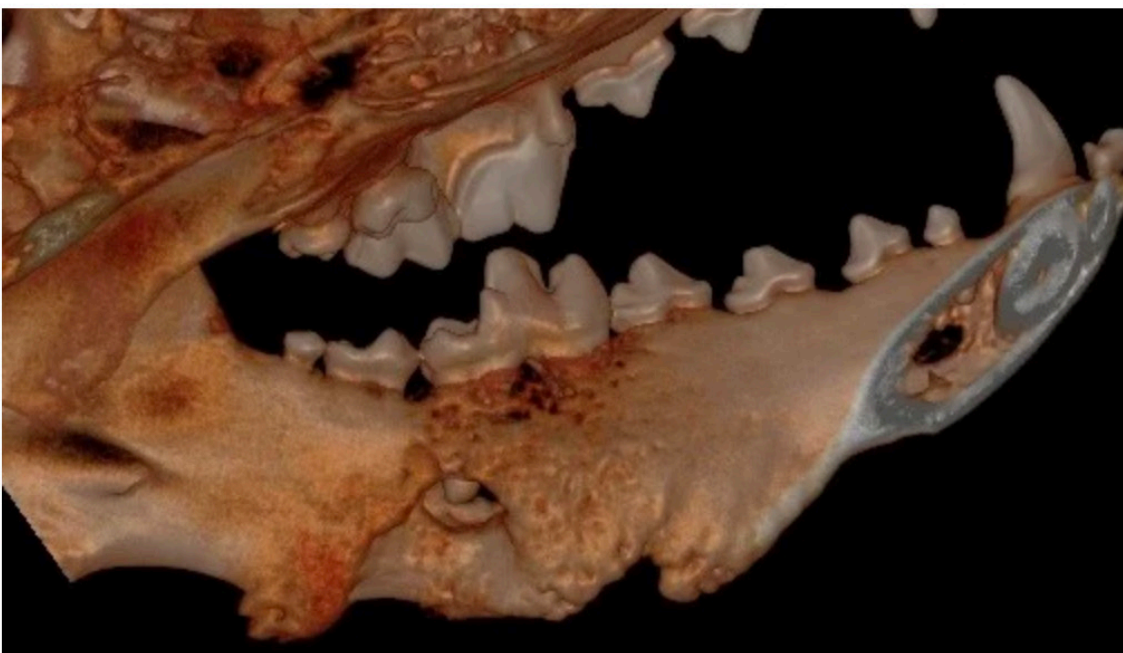
**Below: 3D Hard Tissue Overview (left side)**

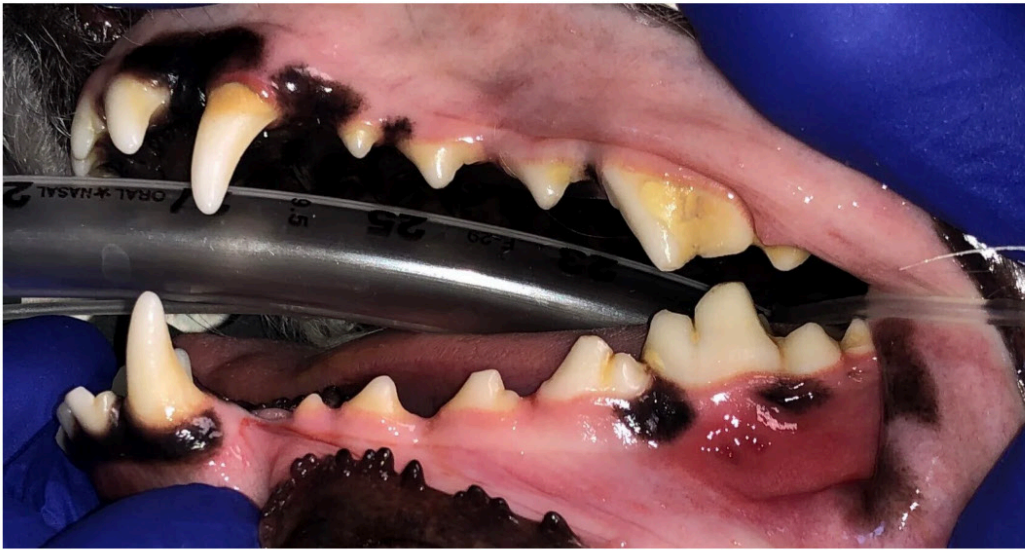
**Below: CT Cross Section of Disease**

The diseased teeth were surgically extracted, and the site was cleaned down to healthy bone. A bone scaffold and membrane (ReGum Vet "mushroom" or "plug") were placed to aid in mandibular healing. ReGum is composed of a cross-linked gelatin foam matrix. It fills the defect and supports the tissue. One of the benefits of ReGum Vet is that it requires no suturing.

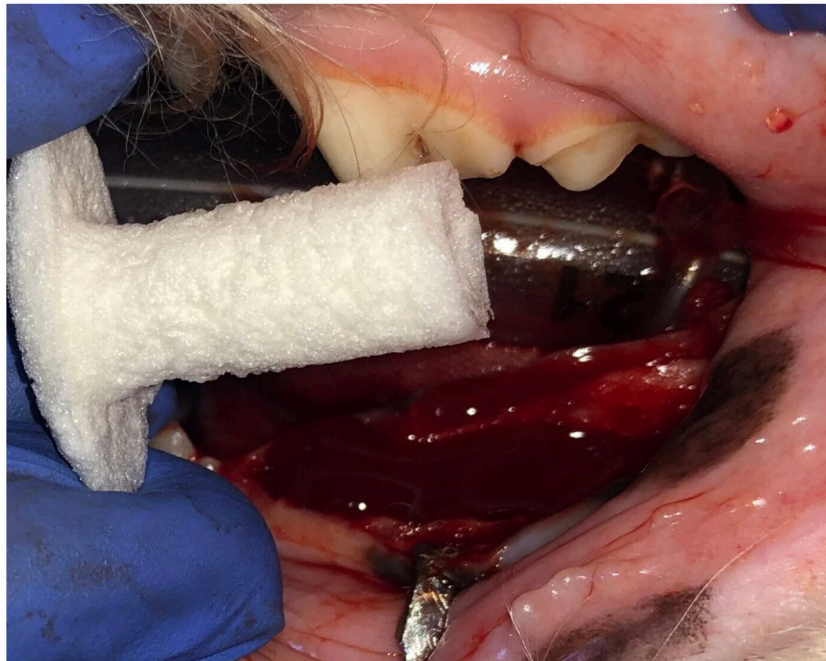
**Below: 3D Hard Tissue Overview (left side)**

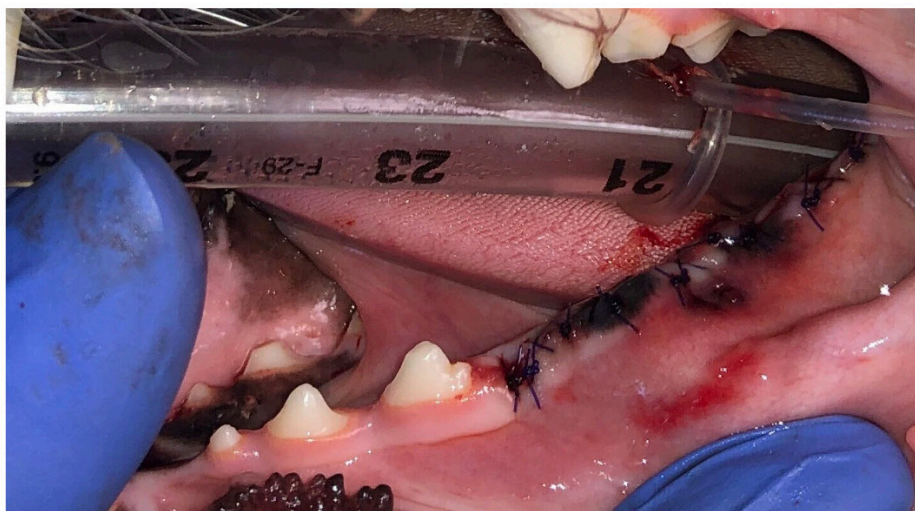
**Below: 3D Hard Tissue Overview (left side)**

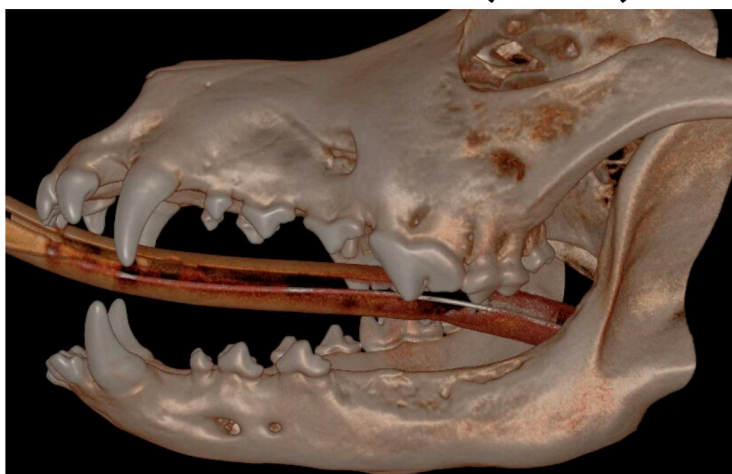
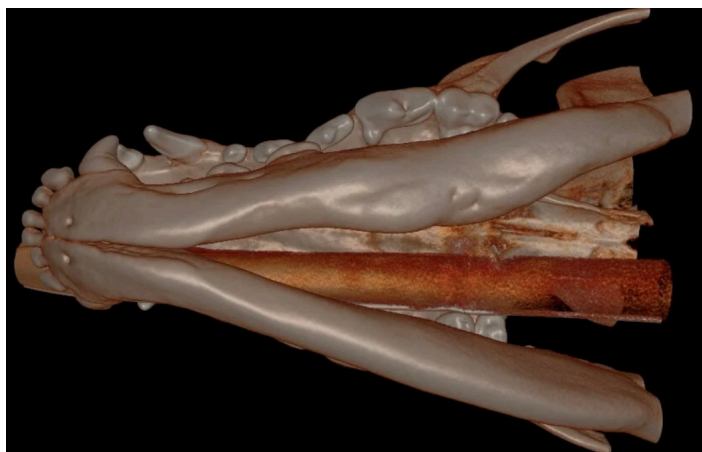
We had the pleasure of seeing Daisy for her four-month follow-up after the ReGum application, and her progress has been remarkable! The bone graft site has healed well, with smooth margins overall, though there are still some minor defects continuing to heal. Importantly, there is no evidence of any further cystic formation.

Hard Tissue Overview (left side)

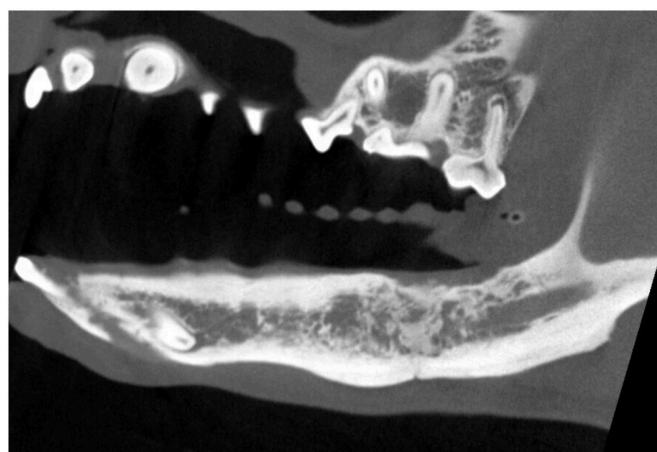
3D Hard Tissue x(ventral aspect)

CT Cross section of the prior disease site, sagittal plane, now with significant healing
